# Walk Around

## F-8 Crusader

Walk Around Number 38  
squadron/signal publications

# Introduction

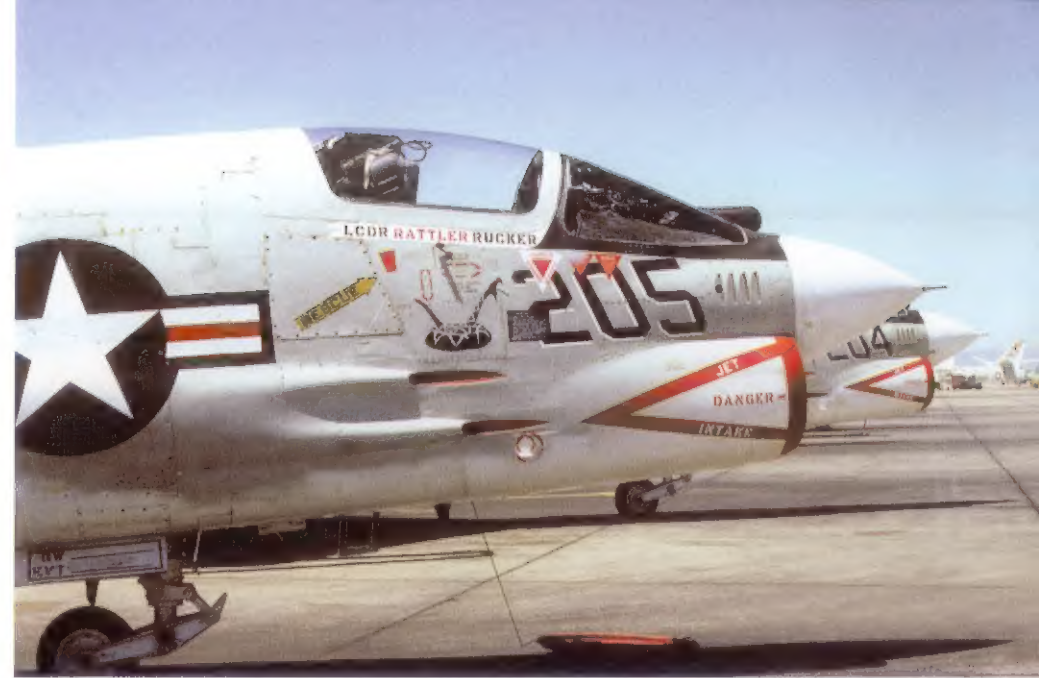
This F-8H's nose profile shows the uneven taper of the upper and lower nose cone surfaces. This resulted from the oval cross section at the fuselage to nose cone interface. The early style flat pitot tube was retained on the F-8H after remanufacture, along with three small cooling vents for the radar system. (Detail & Scale)

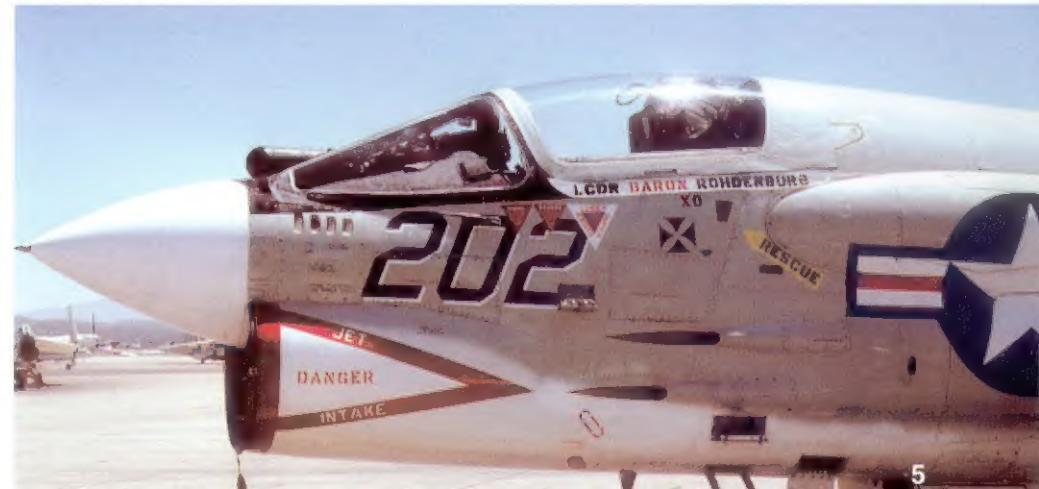
The F-8E/J's right nose side had four cooling vents, as did previous variants. The vents' shape differed on the F-8E/J, which resulted from the tapered fairing required to blend the larger diameter radome to the fuselage. (Trombecky)

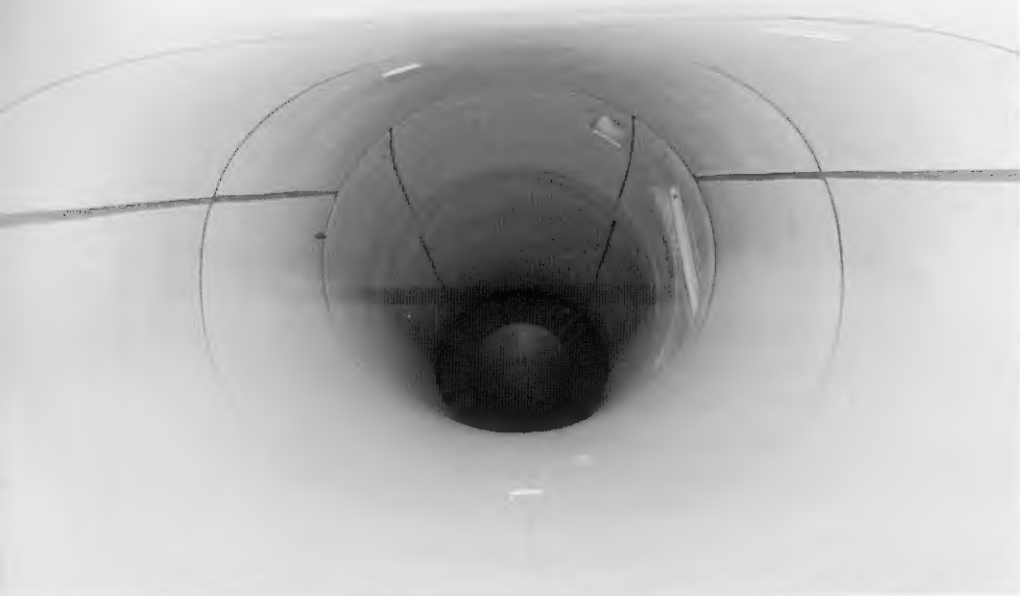
The inlet duct had an oval cross section at its leading edge. This duct ran aft under the cockpit and curved upward to interface with the engine. Inlet trunking segments were sealed at the fabrication seams to prevent air bypass. The duct bypass is located on the trunk's left side (right in this image). An auxiliary air bleed for the environmental system heat exchanger was located above the duct bypass. (Nick)

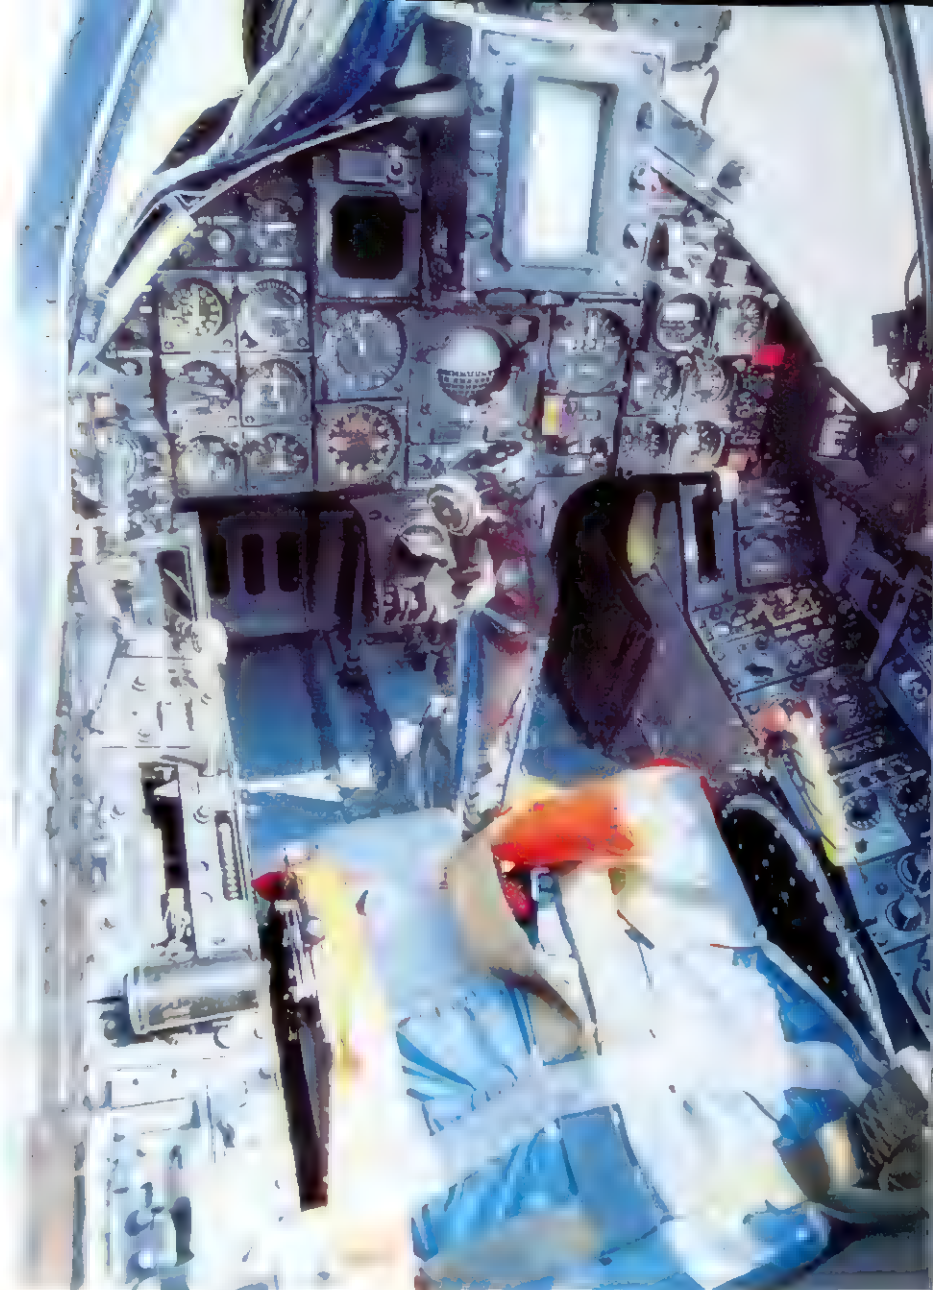
The F-8E (FN) P cockpit differed slightly from the original *Aéronavale* aircraft. The main differences were adding the SHERLOC RWR screen left of the AN/APG-104 radar scope and the improved ILS display. After July of 1994, the 'P' also received the Martin-Baker Mk-F7 ejection seat with a French survival pack. This seat replaced the Martin-Baker Mk-F5A seat originally installed on French Crusaders. (French Navy)

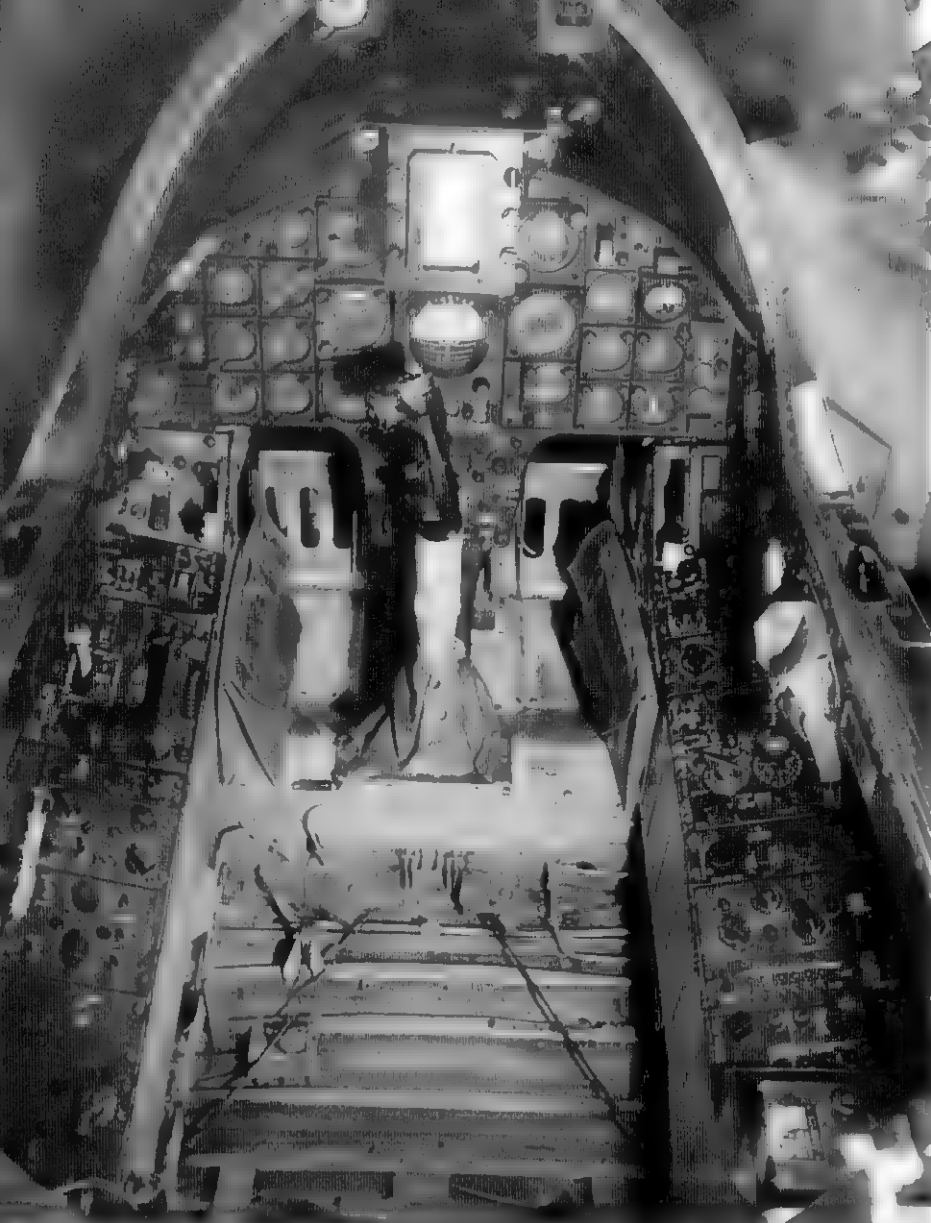
The original French Crusader's cockpit layout was basically identical to the US F-8E, except for the added BLCS controls. The F-8E (FN) had a 5-inch (12.7 cm) tall screen for the Magnavox AN/APQ-104 radar. Removal of the ejection seat exposed the intake trunk roof that formed the cockpit floor. All Crusaders had the foot well recessed in the front cockpit, which provided additional clearance for the pilot. (Gall)

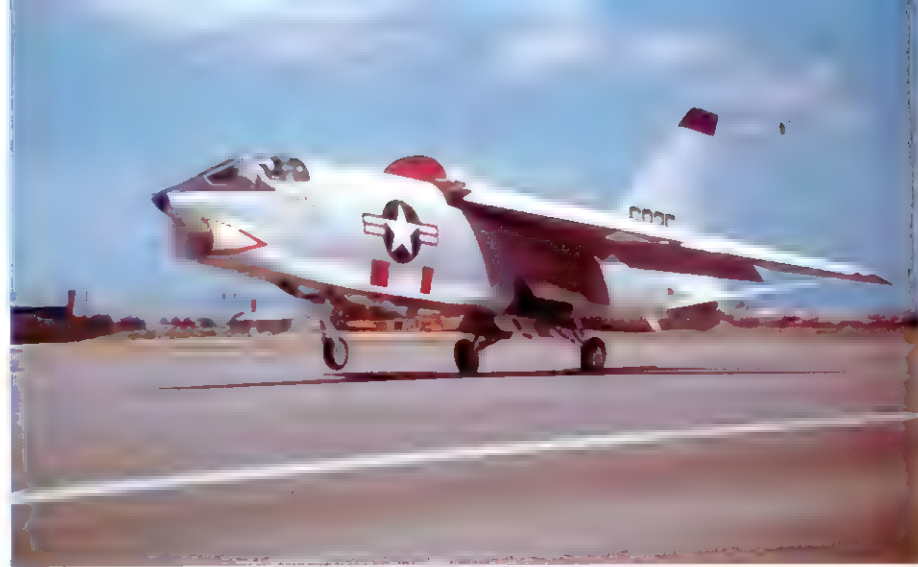
The F8U-1P (RF-8A from 18 September 1962) had squared-off fuselage sides, which provided flat surfaces for the electrically heated optical glass panels. These panels were required to yield the optimum photo quality. The flat sides were blended into the upper fuselage and curved intake air duct. Camera station 2L (2 Left) was located on the forward left fuselage. Station 3 was placed aft of 2L on the lower left fuselage. Red covers are placed over the camera windows for this test flight. (Vought)

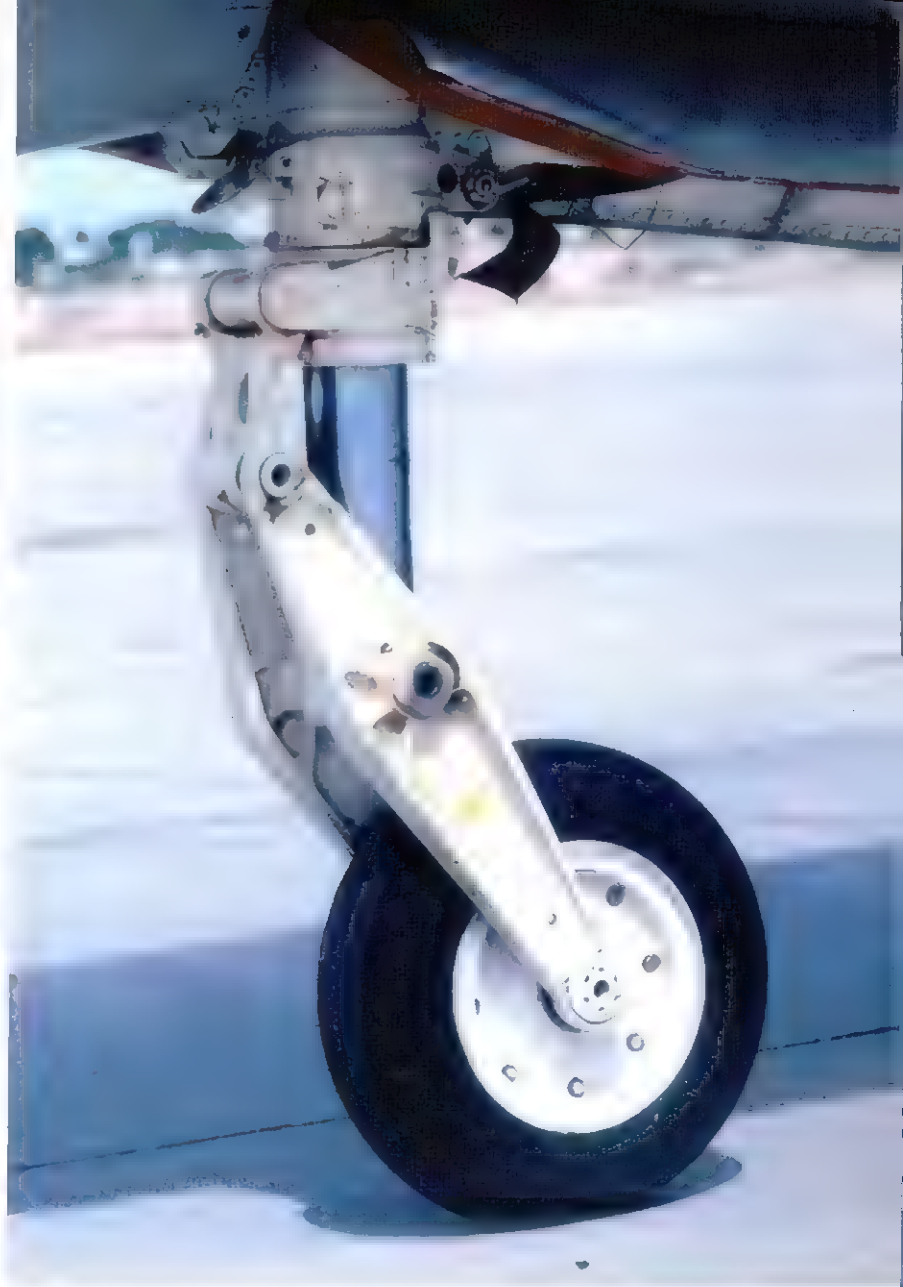
The RF-8's nose landing gear development followed the same progression as on the F-8 fighters. This RF-8G has fully extended the later style gear, which is easily identified by the 'skid horns' mounted on the front of the upper gear strut section. A yellow anchor painted high on the strut indicated where to place a chain for securing the aircraft to the ground or carrier deck. (Trombecky)

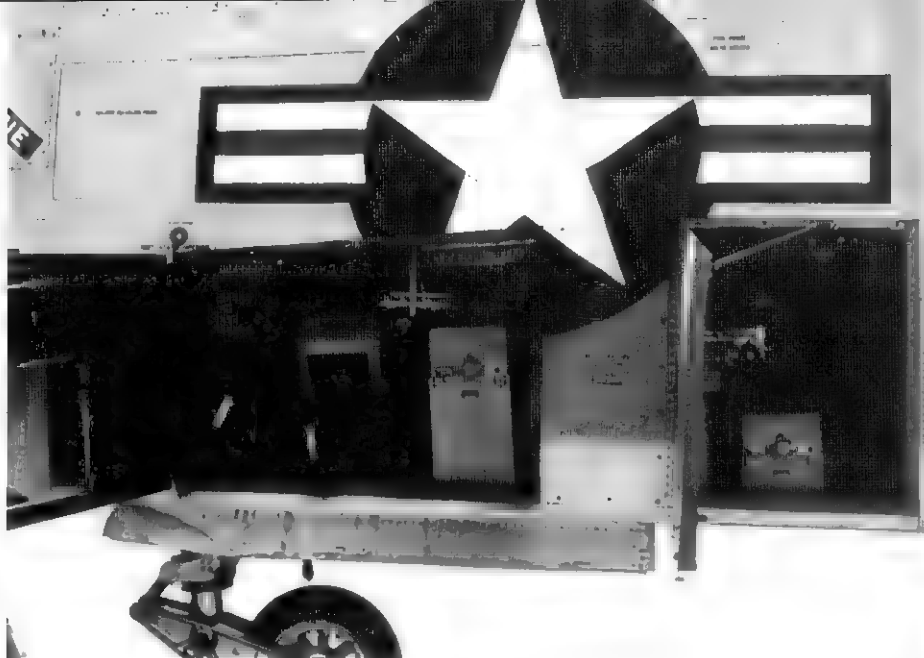
Access doors are open on stations 2 (left of picture) and 3 on the lower left fuselage of this early RF-8A. The forward-hinged doors allowed technicians to easily remove and replace cameras and film magazines. The rectangular In-flight Refueling Probe (IRP) door is located immediately above stations 2 and 3. (US Navy)

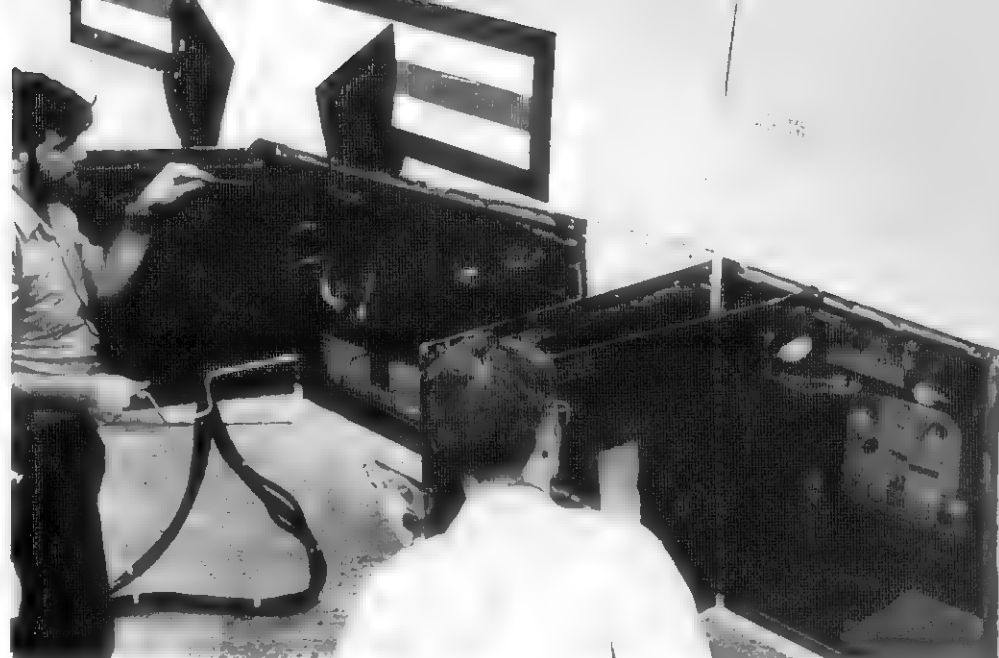
Two ground crewmen service cameras mounted in stations 2 and 3 on this VFP-306 RF-8G. The RF-8A's four camera stations were unchanged when these aircraft were remanufactured to RF-8G standard between 1965 and 1970. A vertically mounted camera is mounted in station 3. (US Navy)
